POST-QUAKE RECREATIONAL OPPORTUNITIES IN THE AVON RIVER
AND THE AVON-HEATHCOTE ESTUARY/IHUTAI

A thesis submitted in partial fulfillment of the
requirements for the Degree
of Master of Water Resource Management
in the University of Canterbury

University of Canterbury

2015

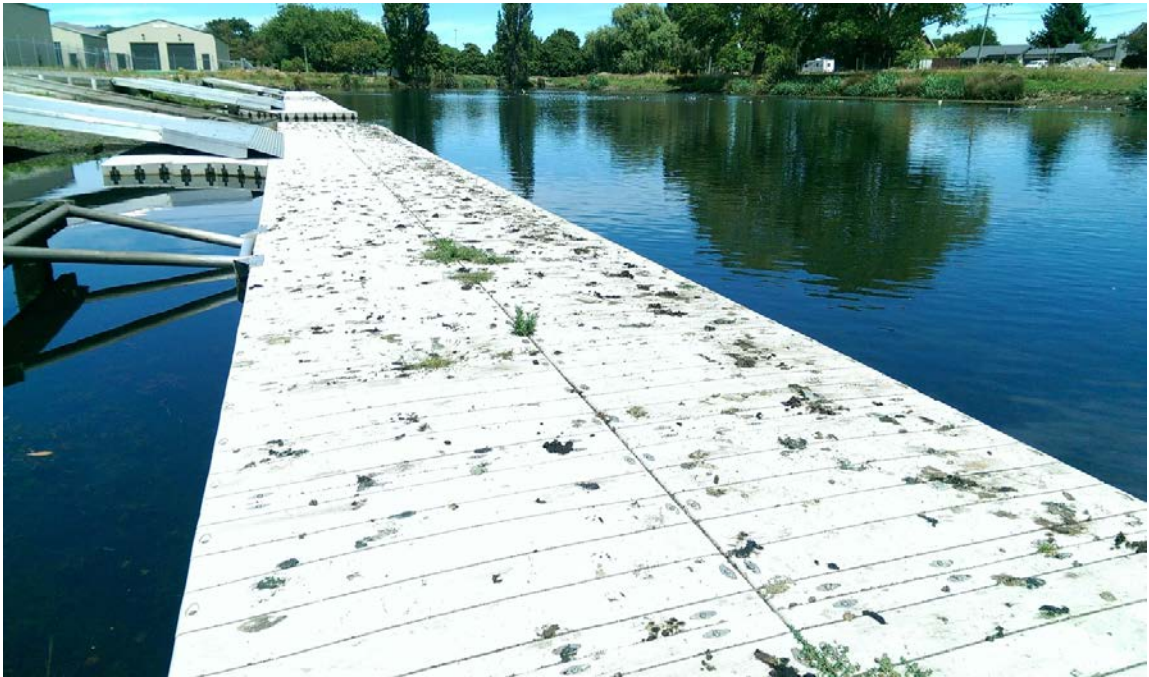
Photo 1 Waterfowl faeces on floating pontoons at Kerrs Reach.

Water quality at the Botanic Gardens, Antigua Boatsheds and Moncks Bay was mainly perceived as reasonable to good. The water at Pleasant Point Jetty was described as poor to good. Kerrs Reach was the only location where participants mainly perceived the water as poor (Figure 2.11). Rowers and a few residents at Kerrs Reach mostly mentioned that nutrients, animal faeces and storm water run-off were key sources contributing to the degradation of water quality. Few recreational users at this location were influenced by the aesthetic appeals of water. For instance, they noted an excessive growth of weed and algae at the location as well as animal faeces that could be commonly seen on pontoons and along the river banks (Photo1 Appendix 8).

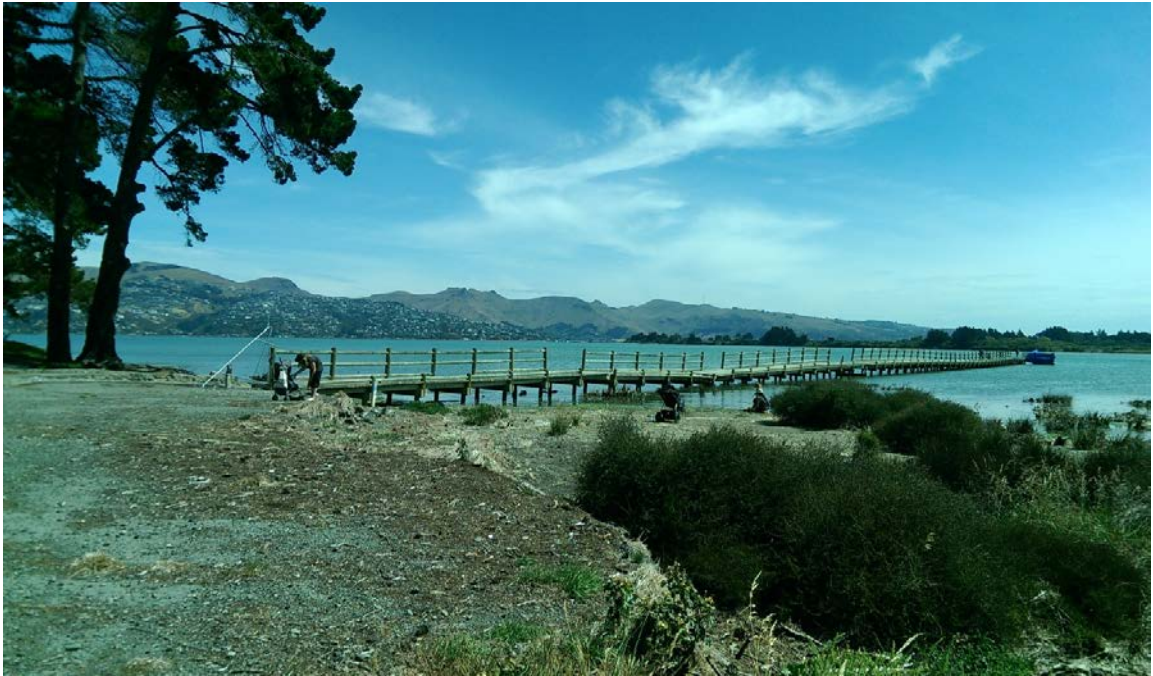
Photo 7 Public continued to use the broken jetty at Pleasant Point Jetty.

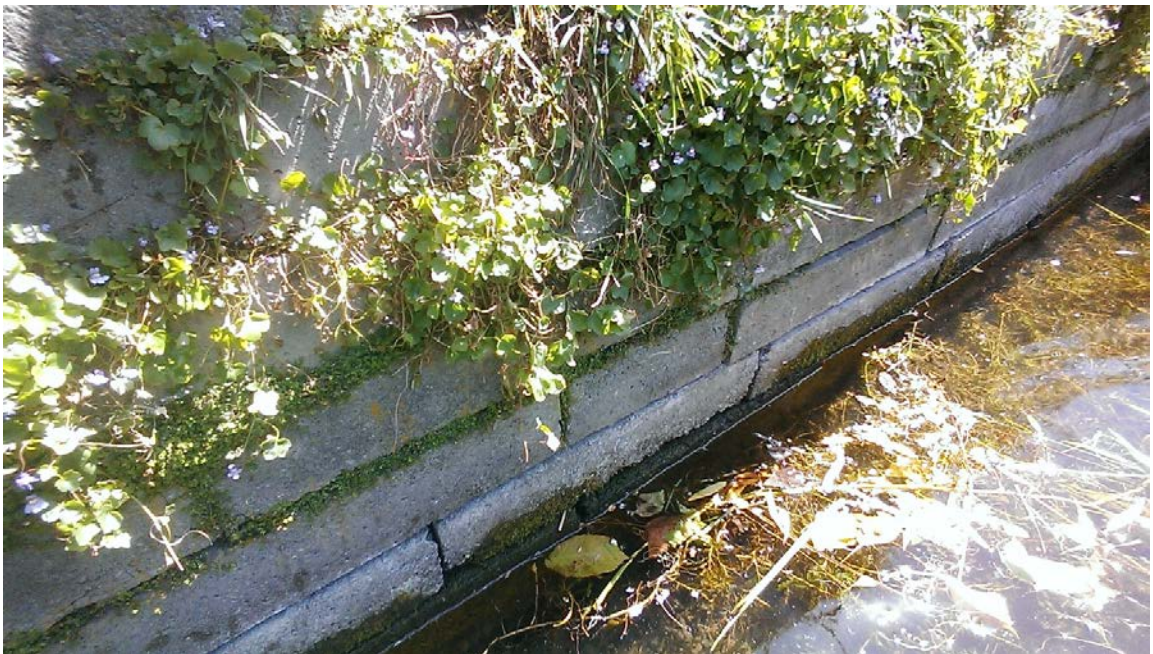
Photo 8 Bank modification made from cement blocks at the Botanic Gardens.

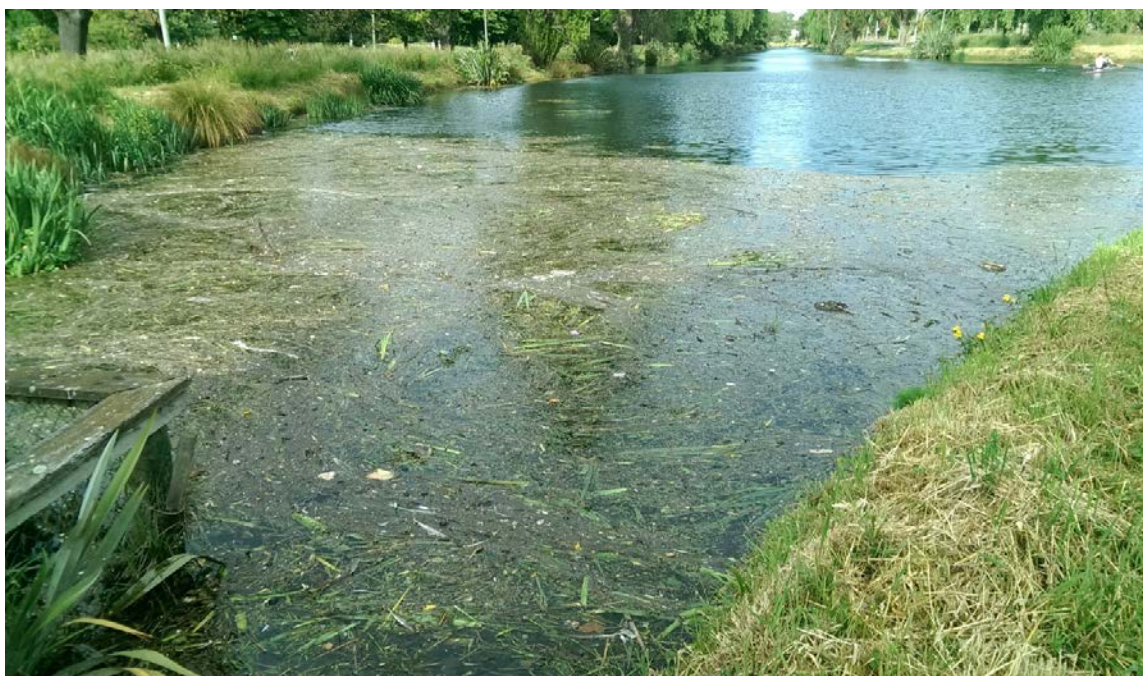
Photo 10 Grass waste floating in the Avon River at Kerrs Reach.

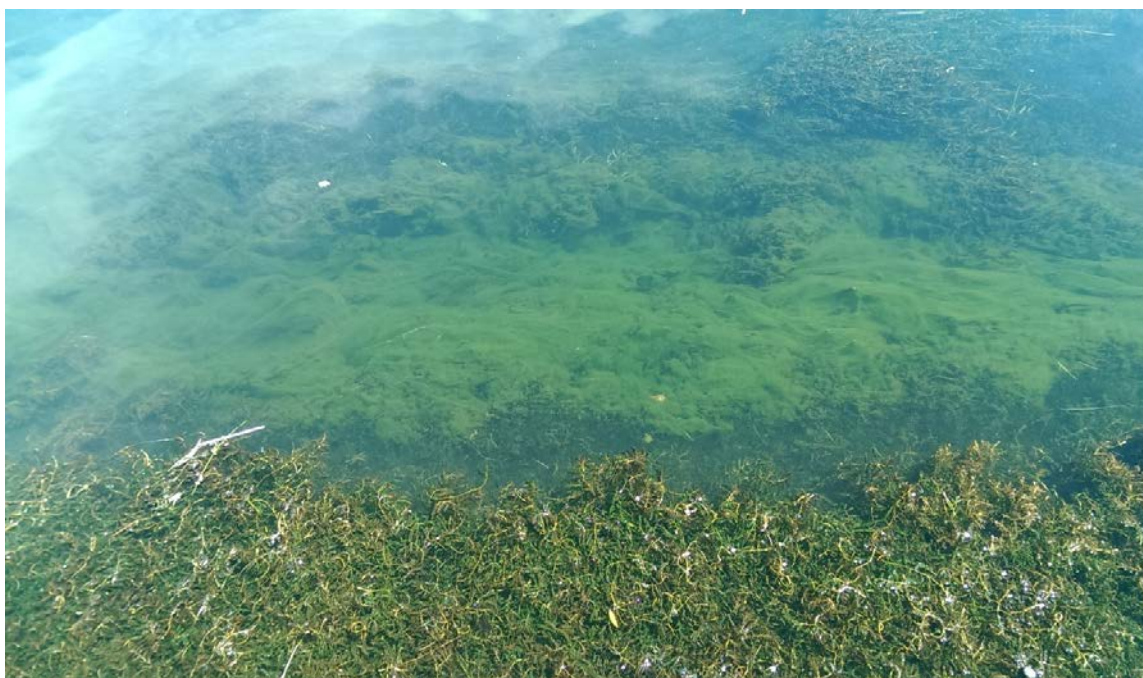
Photo 11 Excessive growth of aquatic plants and green algae along river margins at Kerrs Reach.

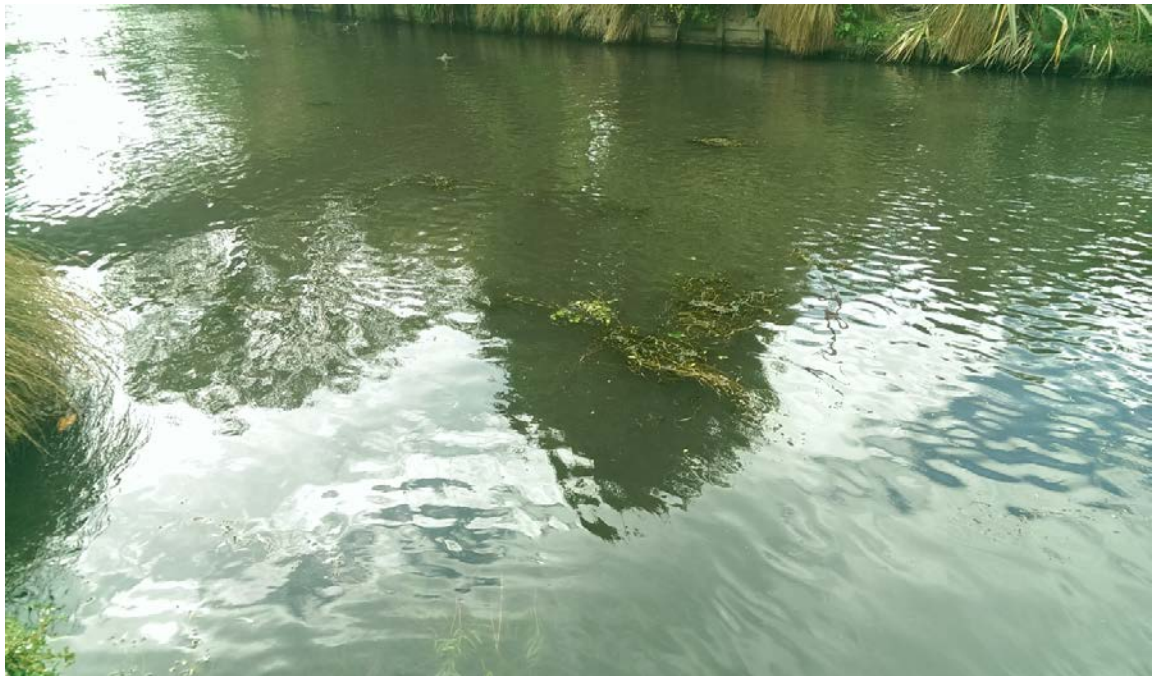
Photo 14 Turbid water due to the removal aquatic plants at the Botanic Gardens.
